# Manhole Inspection Summary

Manhole # S13UU1010MH

Insp Date: **5/8/08 11:44 AM**

**Location** Address: **NORTHERN PKWY**

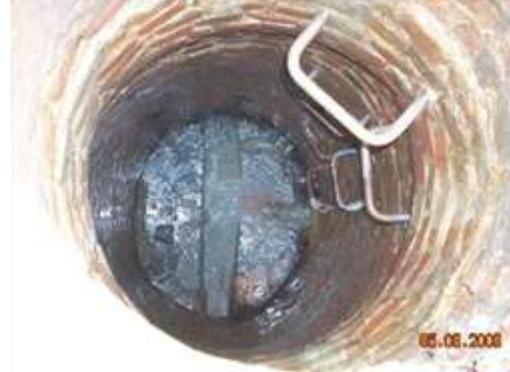
Top View

Corroded steps. Evidence of surcharge - Bench debris.

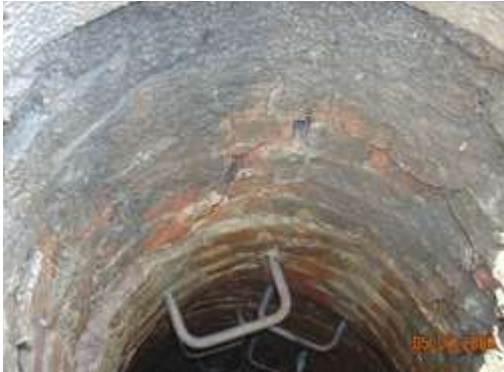
Defect

Frame leaks. Adjustment infiltration. Corbel deterioration, cracks and infiltration.

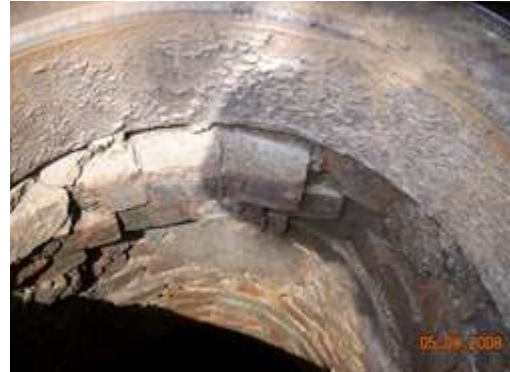
Defect

Frame leaks. Adjustment deterioration, loose brick and infiltration.

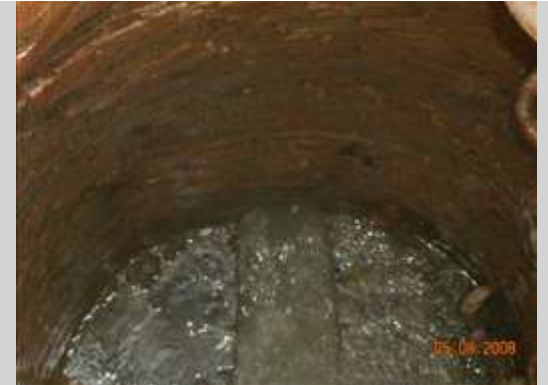
### 10 in. Circular Gravity Sewer Pipe Out @ 12 O'Clock

Pipe Material: **Clay** ☐ Pipe Lined

Invert Depth: **12.70** (ft.) Flow Characteristics: **Fast**

Infiltration: **None** Pipe Seal Cond: **Unknown**

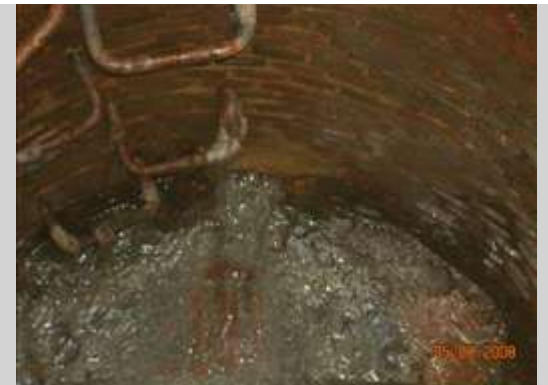
### 8 in. Circular Gravity Sewer Pipe In @ 3 O'Clock

Pipe Material: **Clay** ☐ Pipe Lined

Invert Depth: **11.98** (ft.) Flow Characteristics: **Fast**

Infiltration: **None** Pipe Seal Cond: **Unknown**

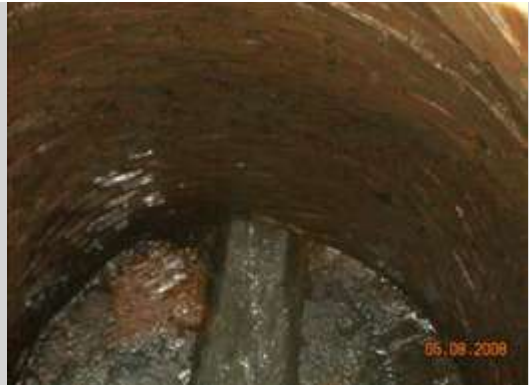
8 in. Circular Gravity Sewer

Pipe Material: **Clay**

Invert Depth: **12.60** (ft.) Flow Characteristics: **Fast**

Infiltration: **None**
